REINFORCED PATCH AT CANADIAN MALARTIC

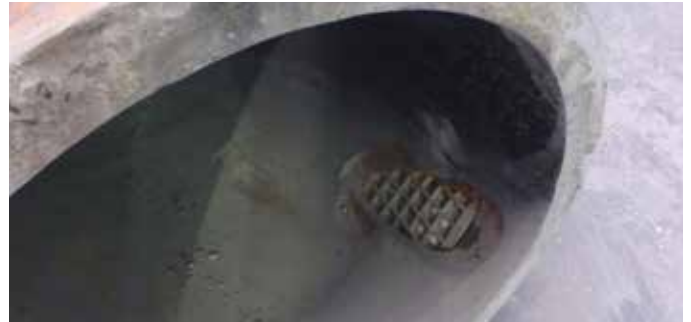
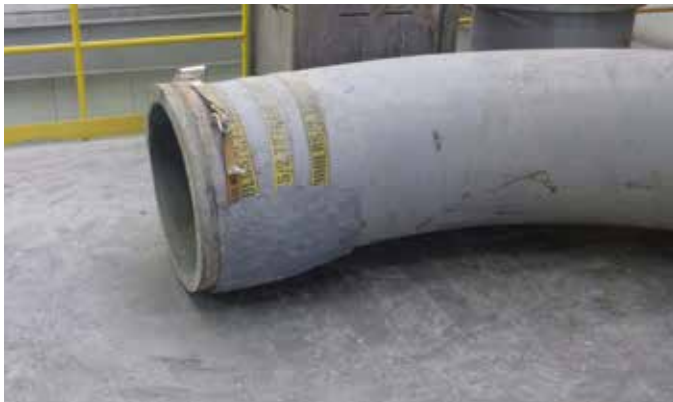
During the plant's crushing operations, steel pipes would burst because they were transporting abrasive fluid.

We suggested a patch that combines urethane and ceramic and is attached with ratchet straps. With the pressure from the straps, the urethane patch molds to the shape of the pipe and plugs the leak. A ceramic compound is then applied to further reinforce the repair and extend the life of the patch.
